Concrete Supply Company - Lincolnton Plant

831 Madison St  
Lincolnton, NC 28092

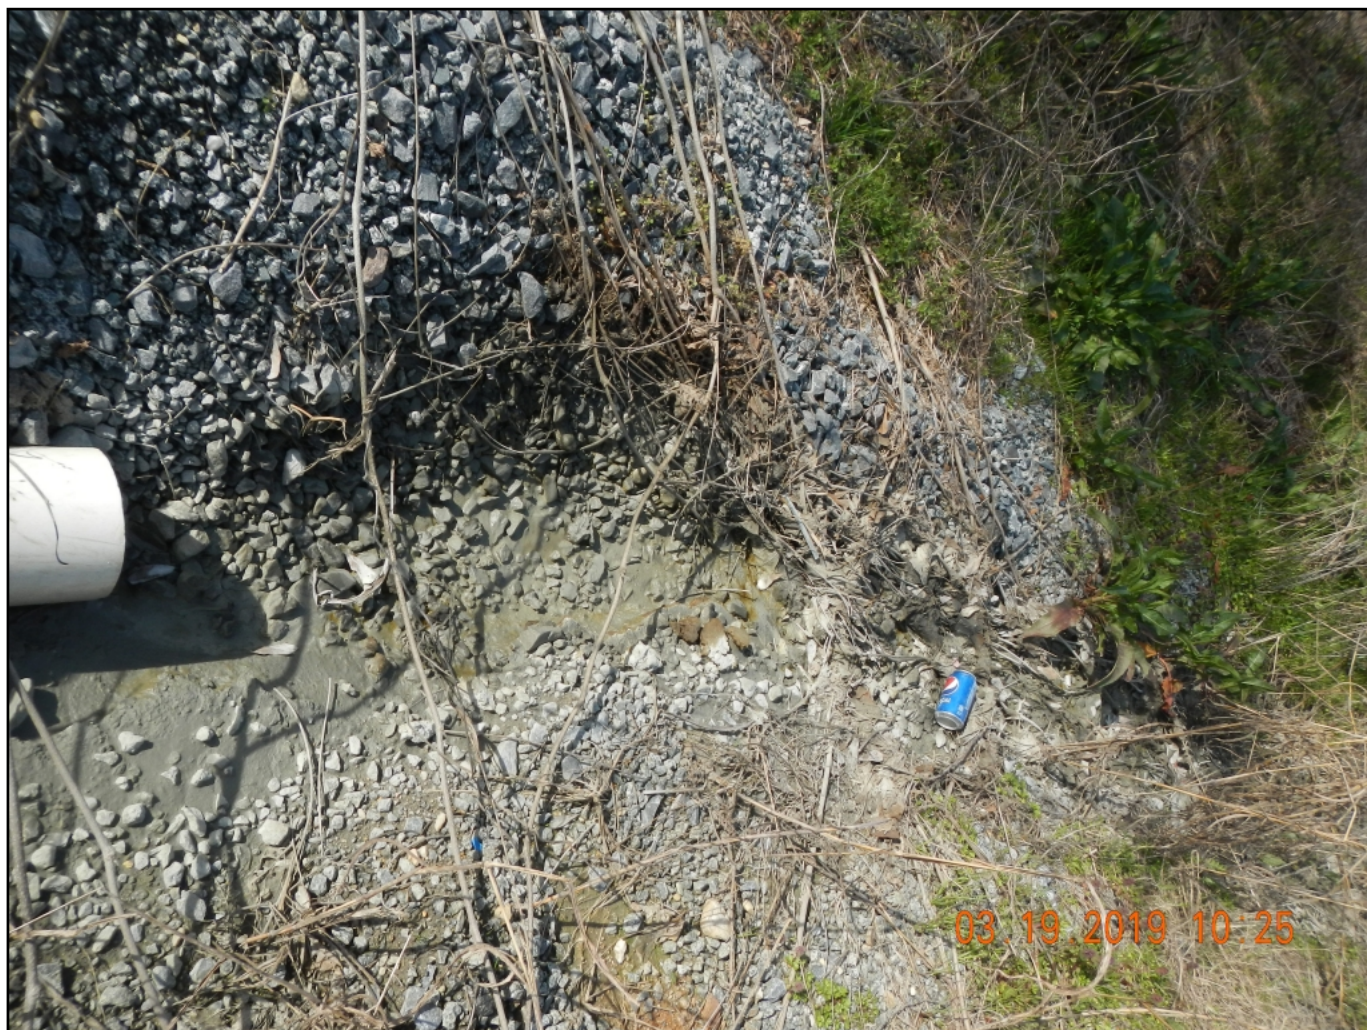
| File Name | DSCN1837.JPG |

| Description | Photograph of the bermed area and inlet at Outfall 1. This outfall, located in the northwest corner of the site, has the potential to discharge both stormwater and wastewater. |

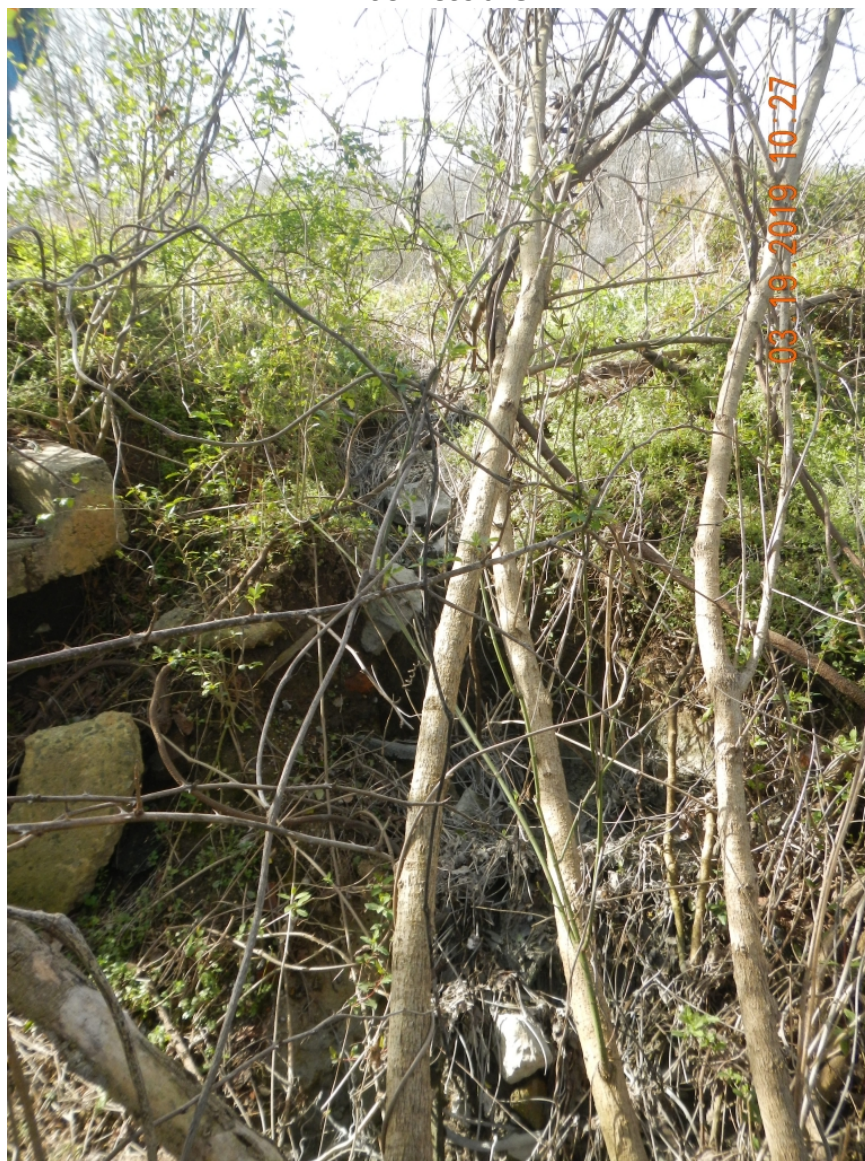
| Attributes | |
|---|--|
| File Name | DSCN1838.JPG |

| Attributes | |
|---|--|
| Description | Photograph of the outlet for Outfall 1. This outfall, located in the northwest corner of the site, has the potential to discharge both stormwater and wastewater. The area downgradient of the outfall had what appeared to be accumulated silty material from the concrete process. |

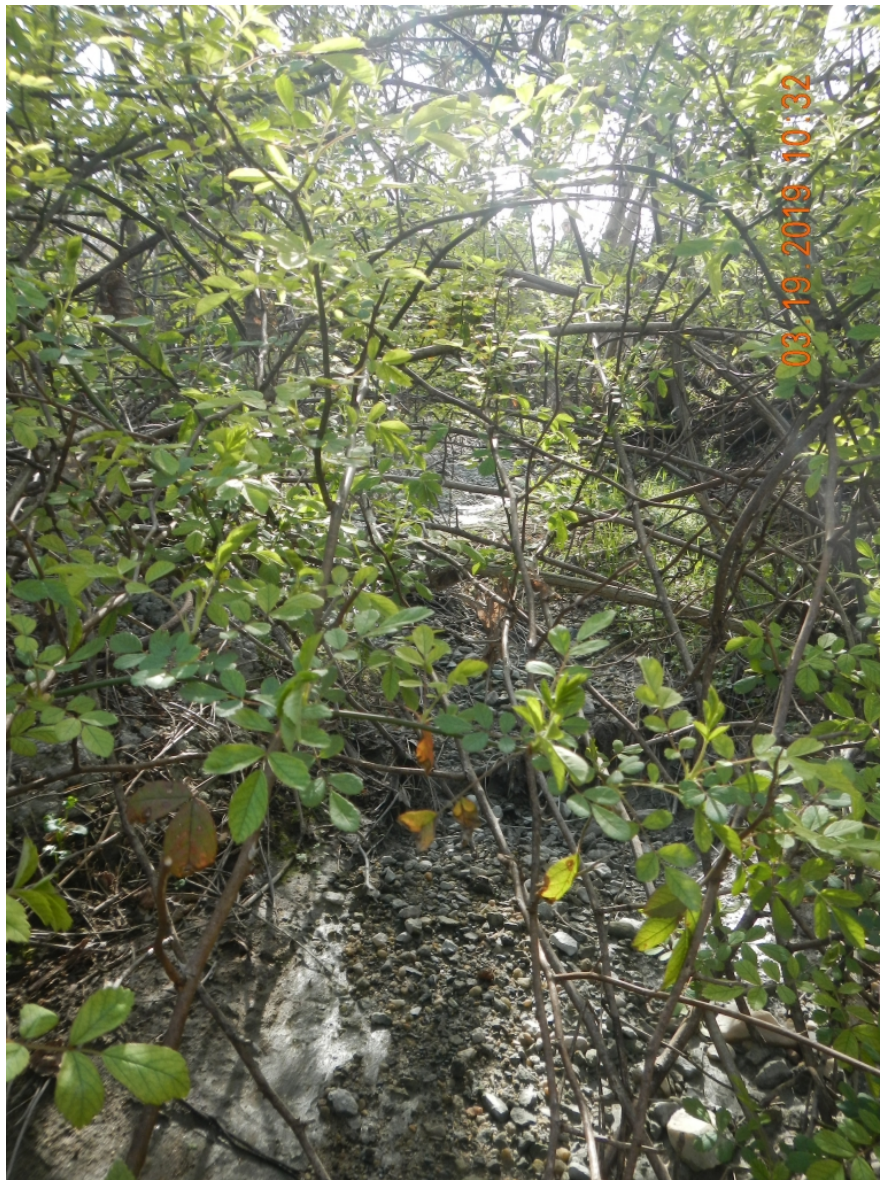
| Attributes | |
|---|--|
| File Name | DSCN1839.JPG |

| Attributes | |
|---|--|
| Description | Photograph of the ditch down gradient of Outfall 1 leading towards the creek. This area appeared to be accumulated silty material from the concrete process. Pooling water was observed in locations in the ditch in addition to the evidence of erosion features. |

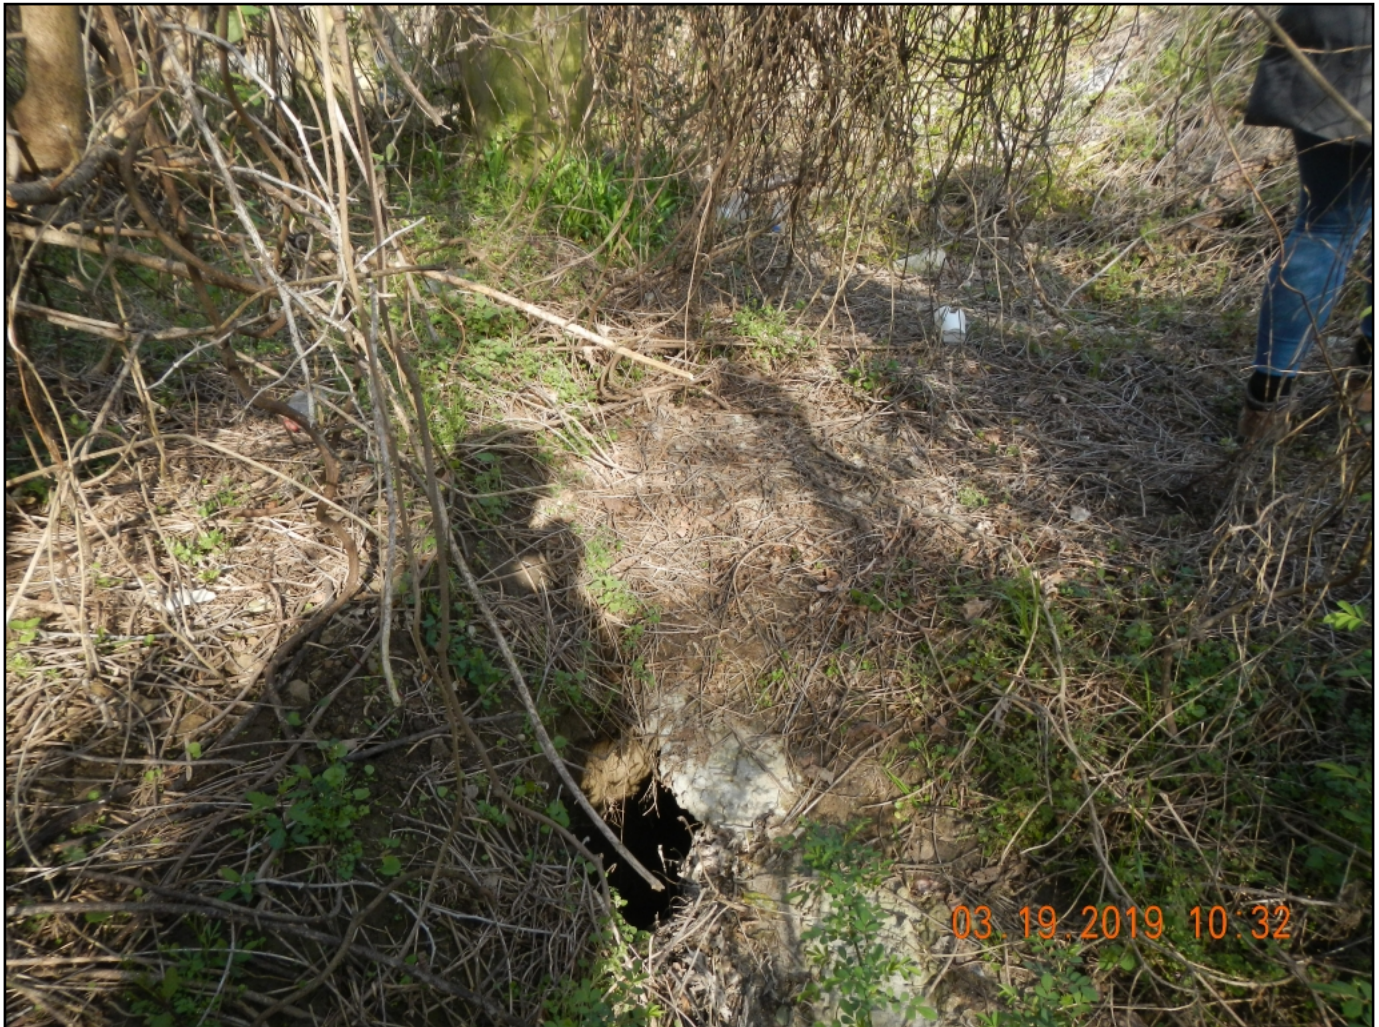
| File Name | DSCN1840.JPG |

| Description | Photograph of the ditch down gradient of Outfall 1 leading towards the creek. Pooling water was observed in locations in the ditch in addition to the evidence of erosion features. |

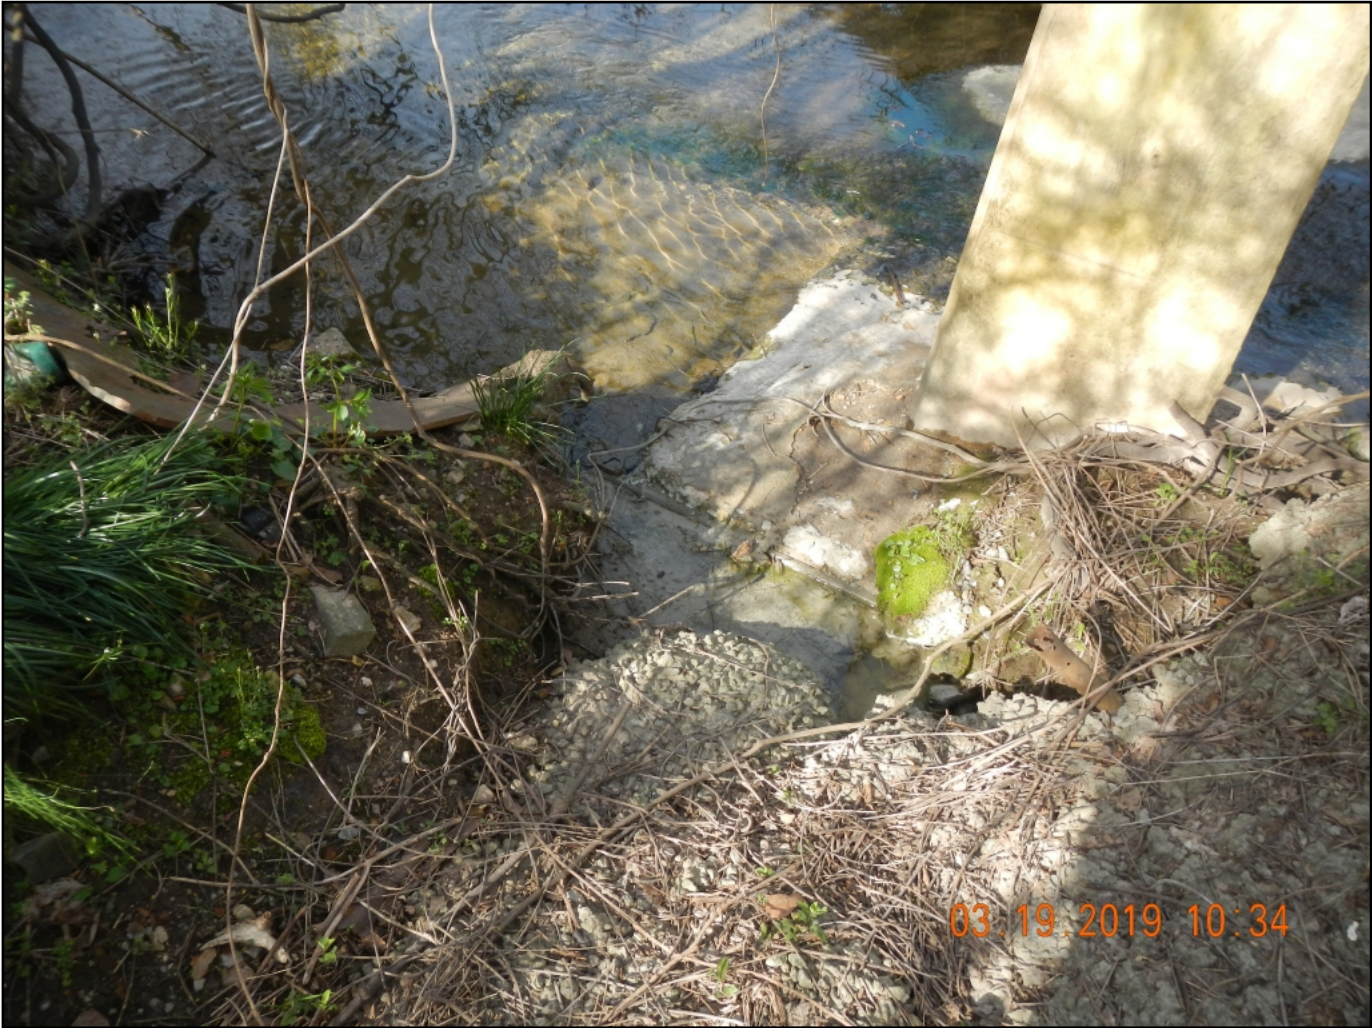
| Attributes | |
|---|---|
| File Name | DSCN1841.JPG |

| Attributes | |
|---|---|
| Description | Photograph of the ditch down gradient of Outfall 1 leading towards the creek. Pooling water was observed in locations in the ditch in addition to the evidence of erosion features. |

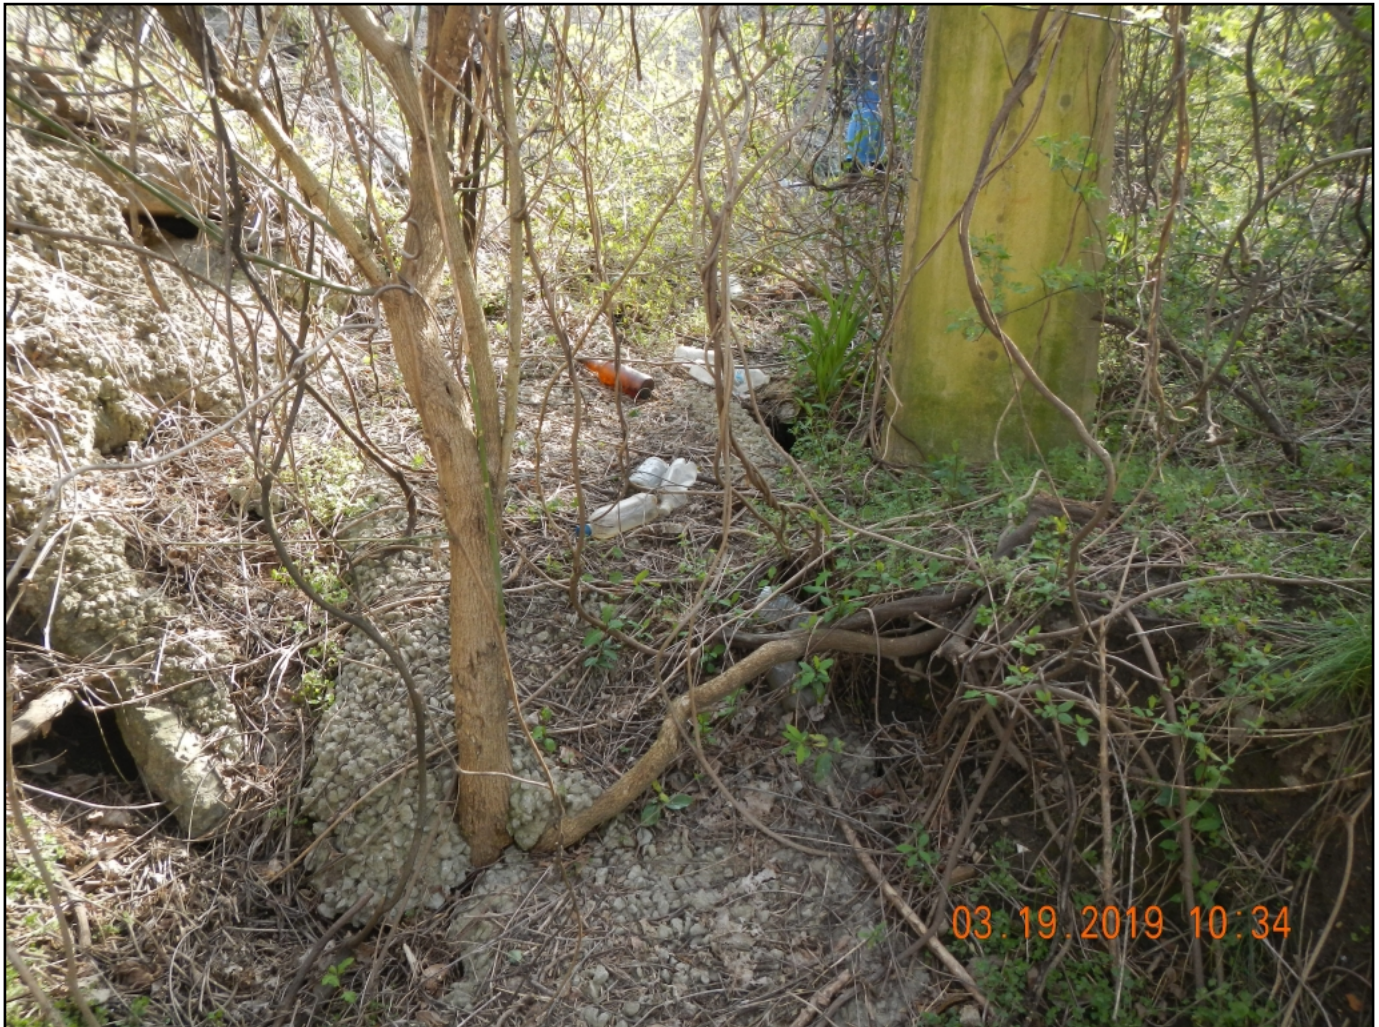
| Attributes | |
|---|--|
| File Name | DSCN1842.JPG |

| Attributes | |
|---|--|
| Description | Photograph of the junction between the creek and the ditch down gradient of Outfall 1. |

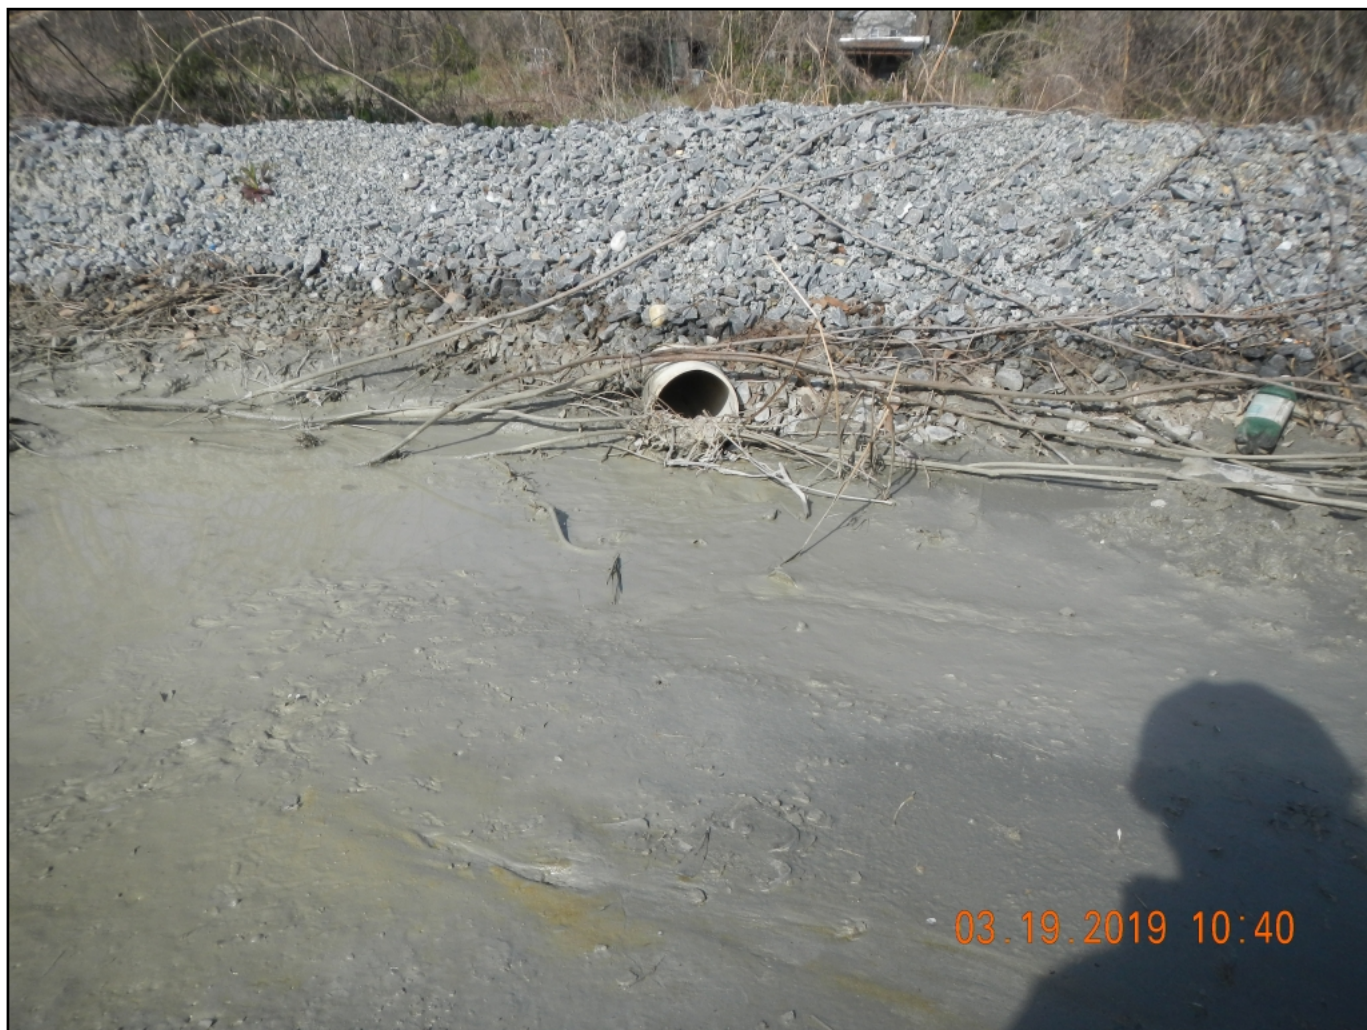
| File Name | DSCN1843.JPG |

| Description | Photograph of the ditch up gradient of junction with the creek. |

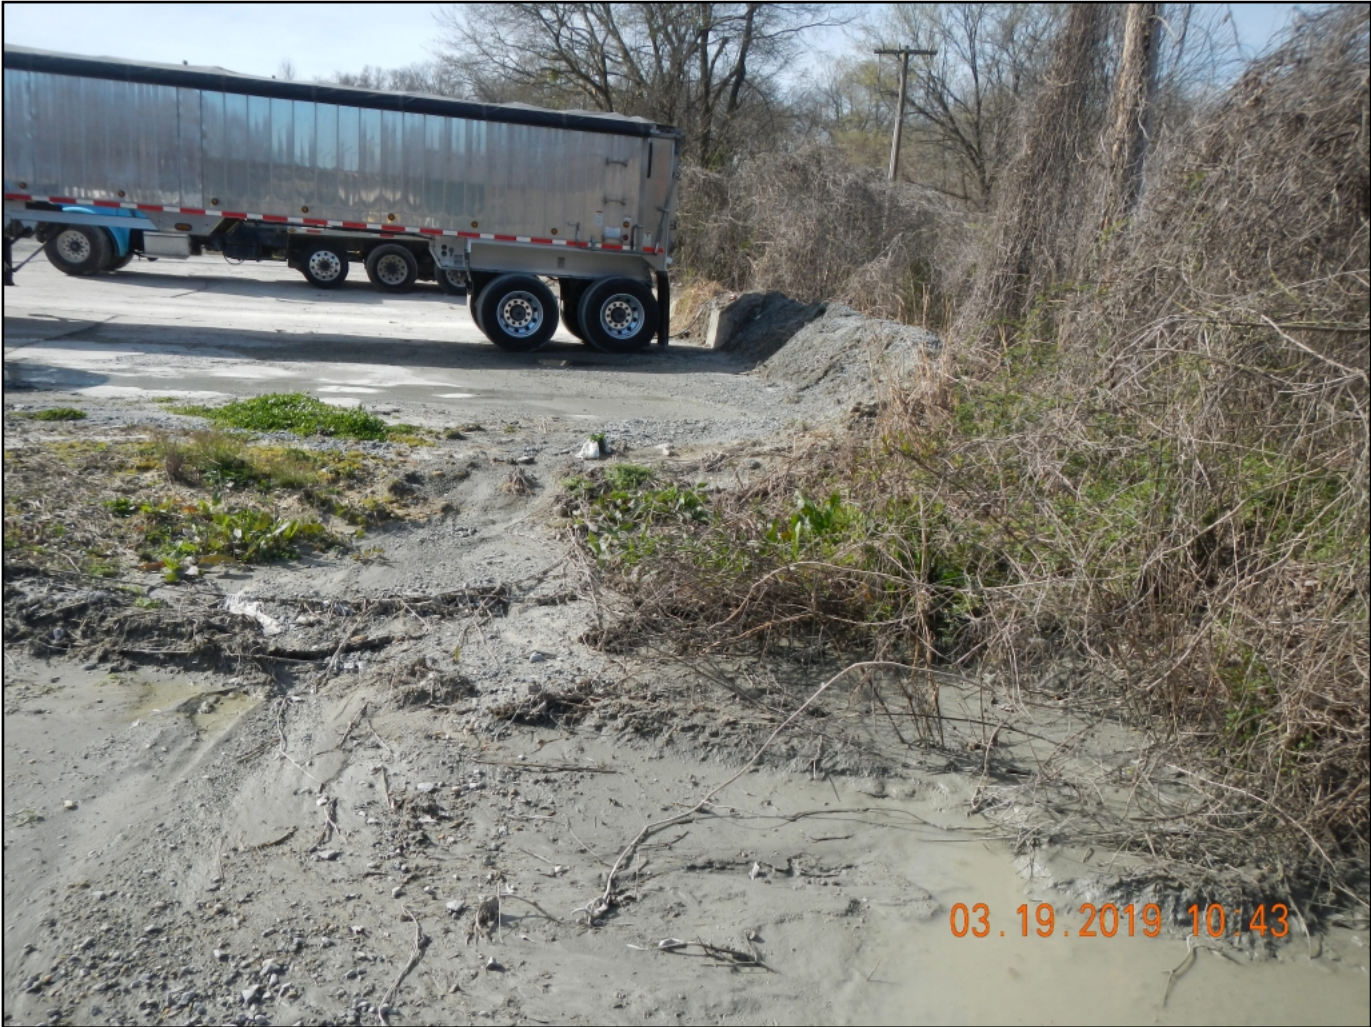
| Attributes | |
|---|--|
| File Name | DSCN1844.JPG |

| Attributes | |
|---|--|
| Description | Photograph of the berm and inlet to the pipe for Outfall 1. During the inspection, the facility side of the berm had damp accumulated sediment to the level of the outfall pipe. |

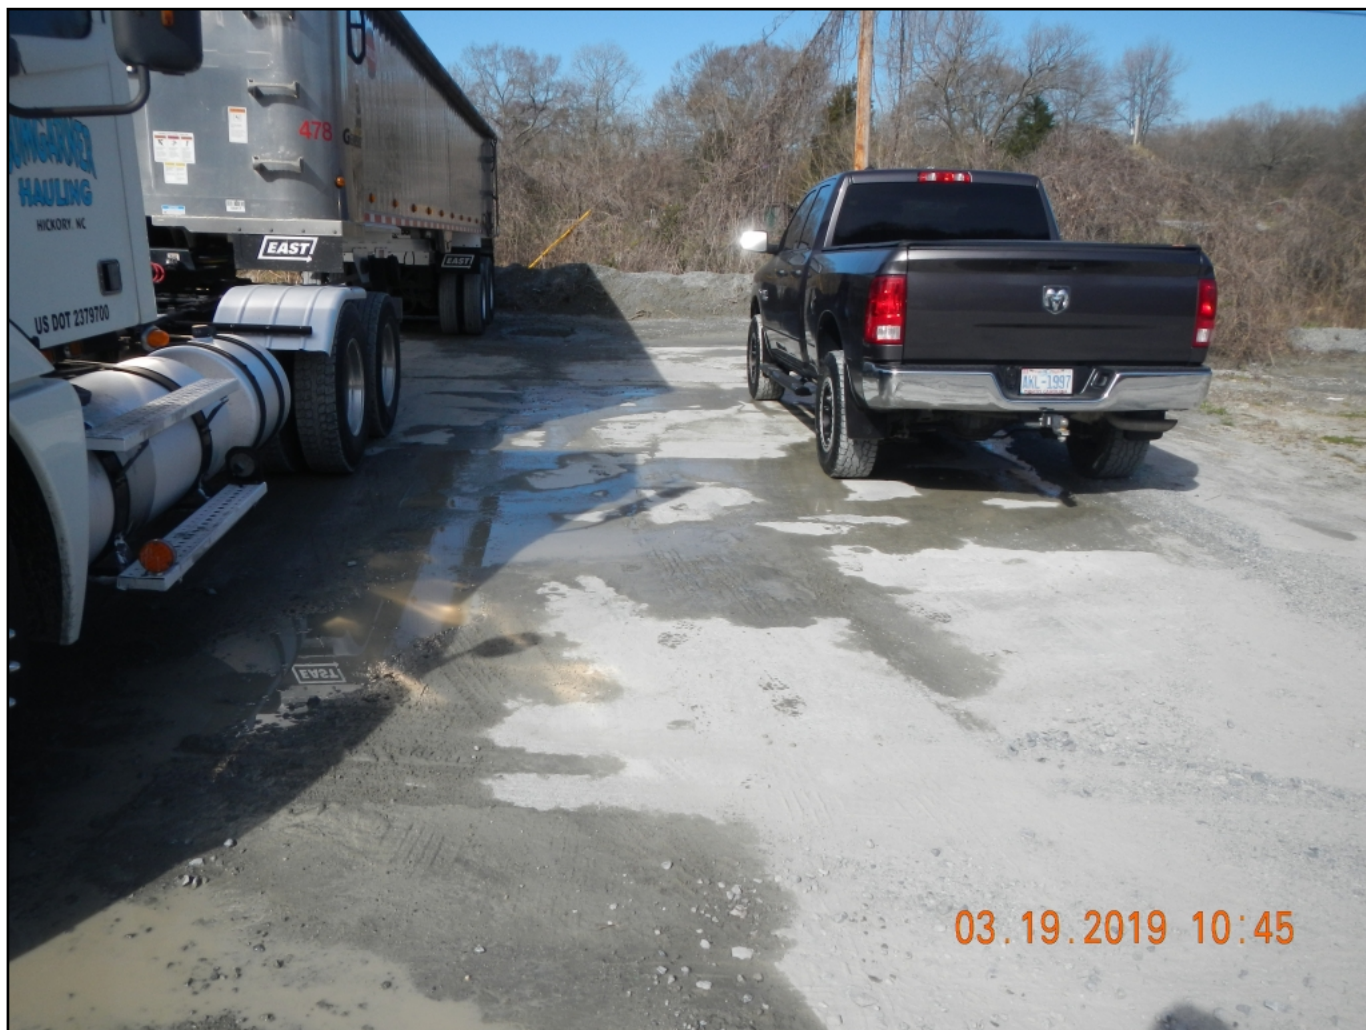
| Attributes | |
|---|--|
| File Name | DSCN1845.JPG |

| Attributes | |
|---|--|
| Description | Photograph of the berm along the river near the outfall. |

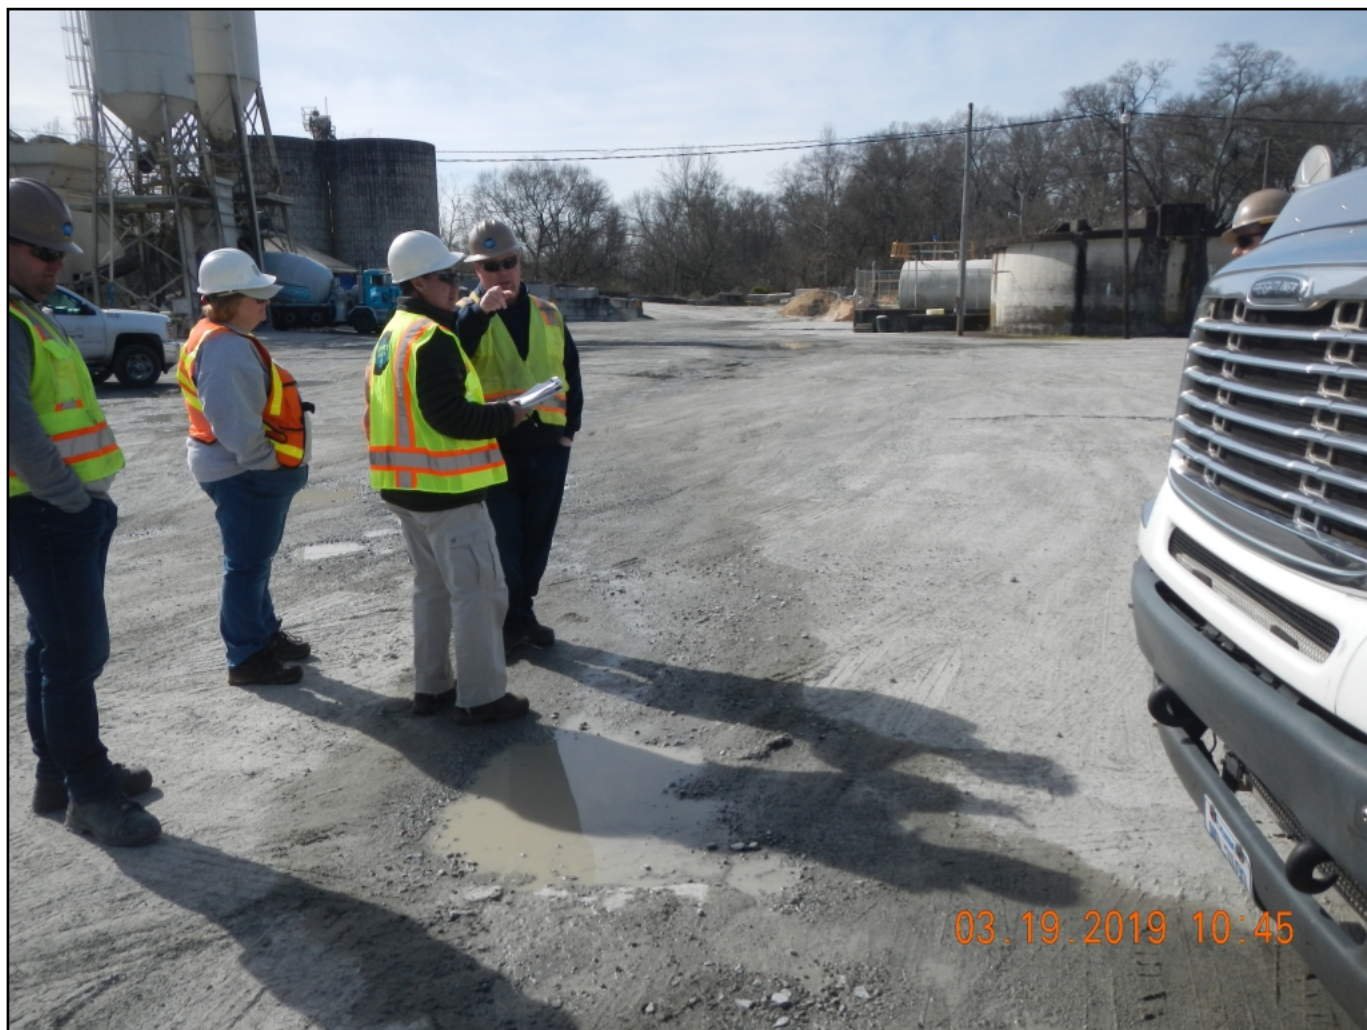
| File Name | DSCN1846.JPG |

| Description | Photograph of wastewater from truck washing operations observed during the site running towards the bermed area near the outfall. |

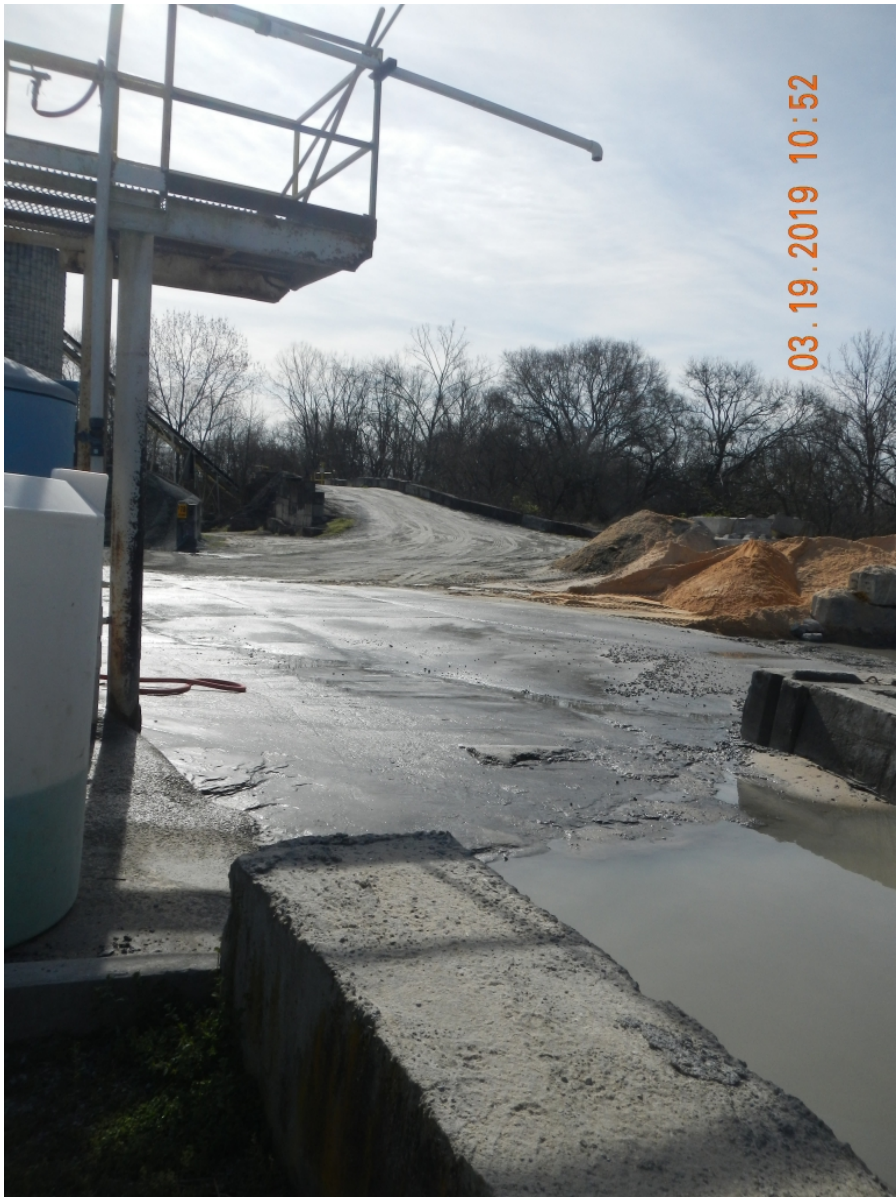
| Attributes | |
|---|---|
| File Name | DSCN1847.JPG |

| Attributes | |
|---|---|
| Description | Photograph of wastewater from truck washing operations observed during the site running towards the bermed area near the outfall. |

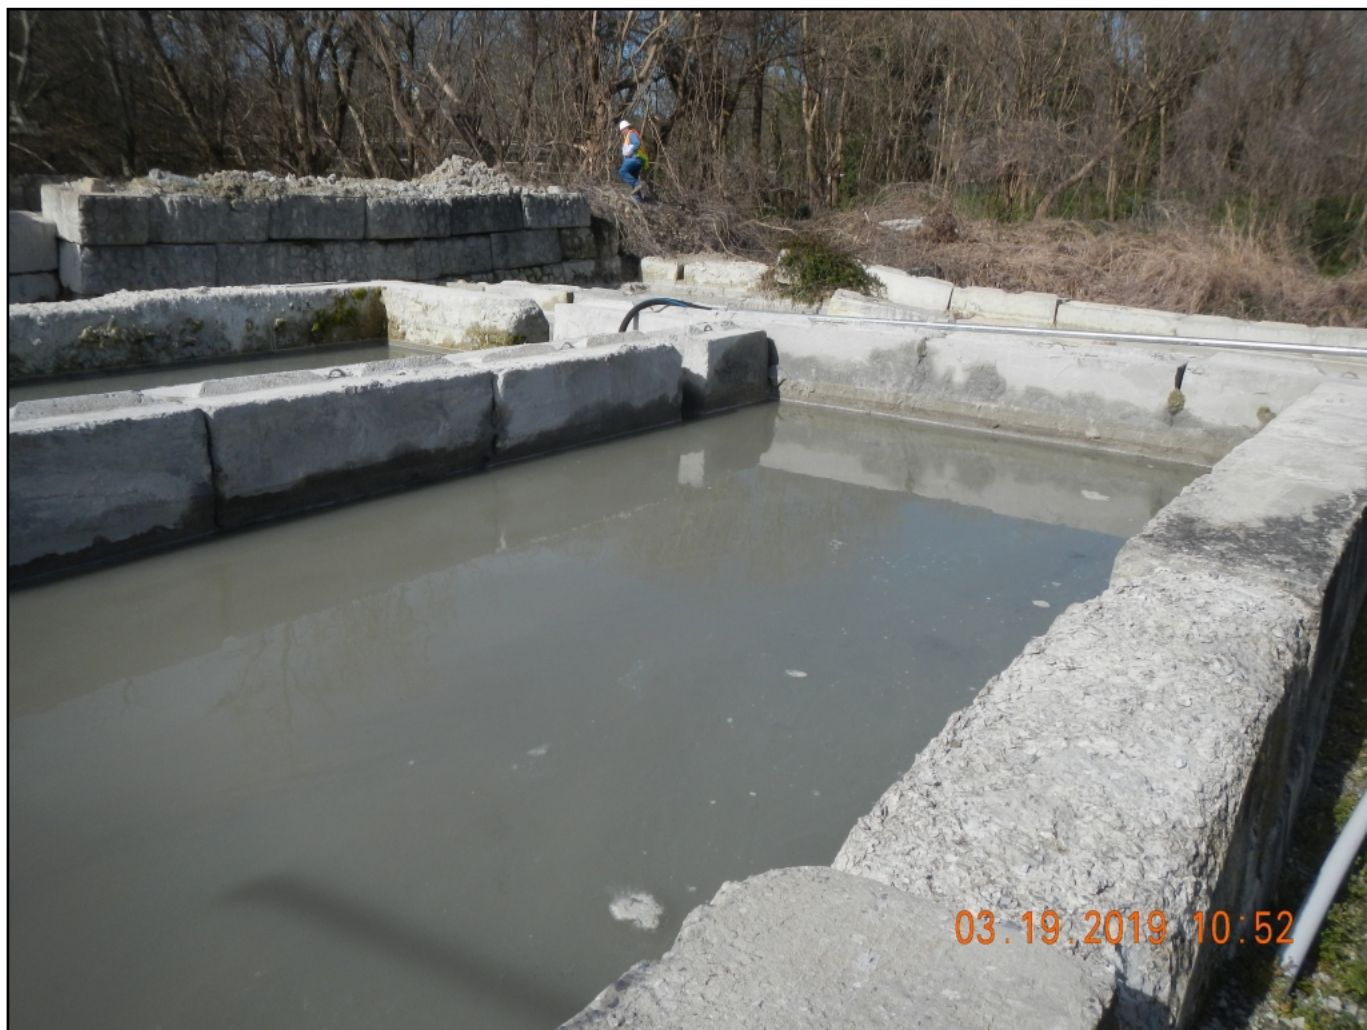
| Attributes | |
|---|--|
| File Name | DSCN1848.JPG |

| Attributes | |
|---|--|
| Description | Photograph of the truck wash station near the concrete wash pit. |

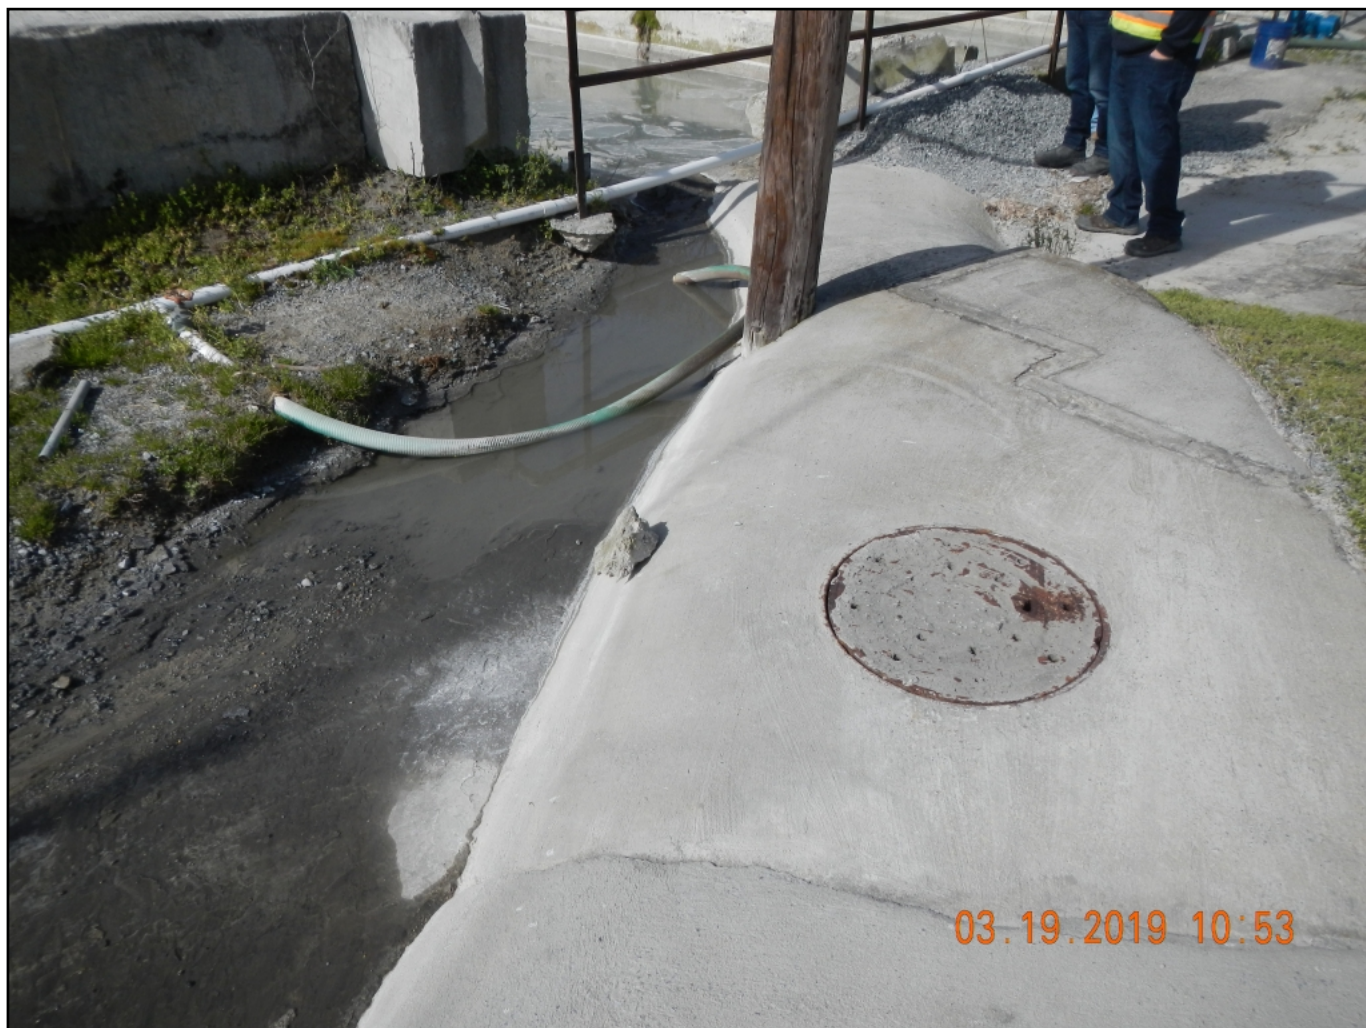
| Attributes | |
|---|---|
| File Name | DSCN1849.JPG |

| Attributes | |
|---|---|
| Description | Photograph of the concrete washout basin. |

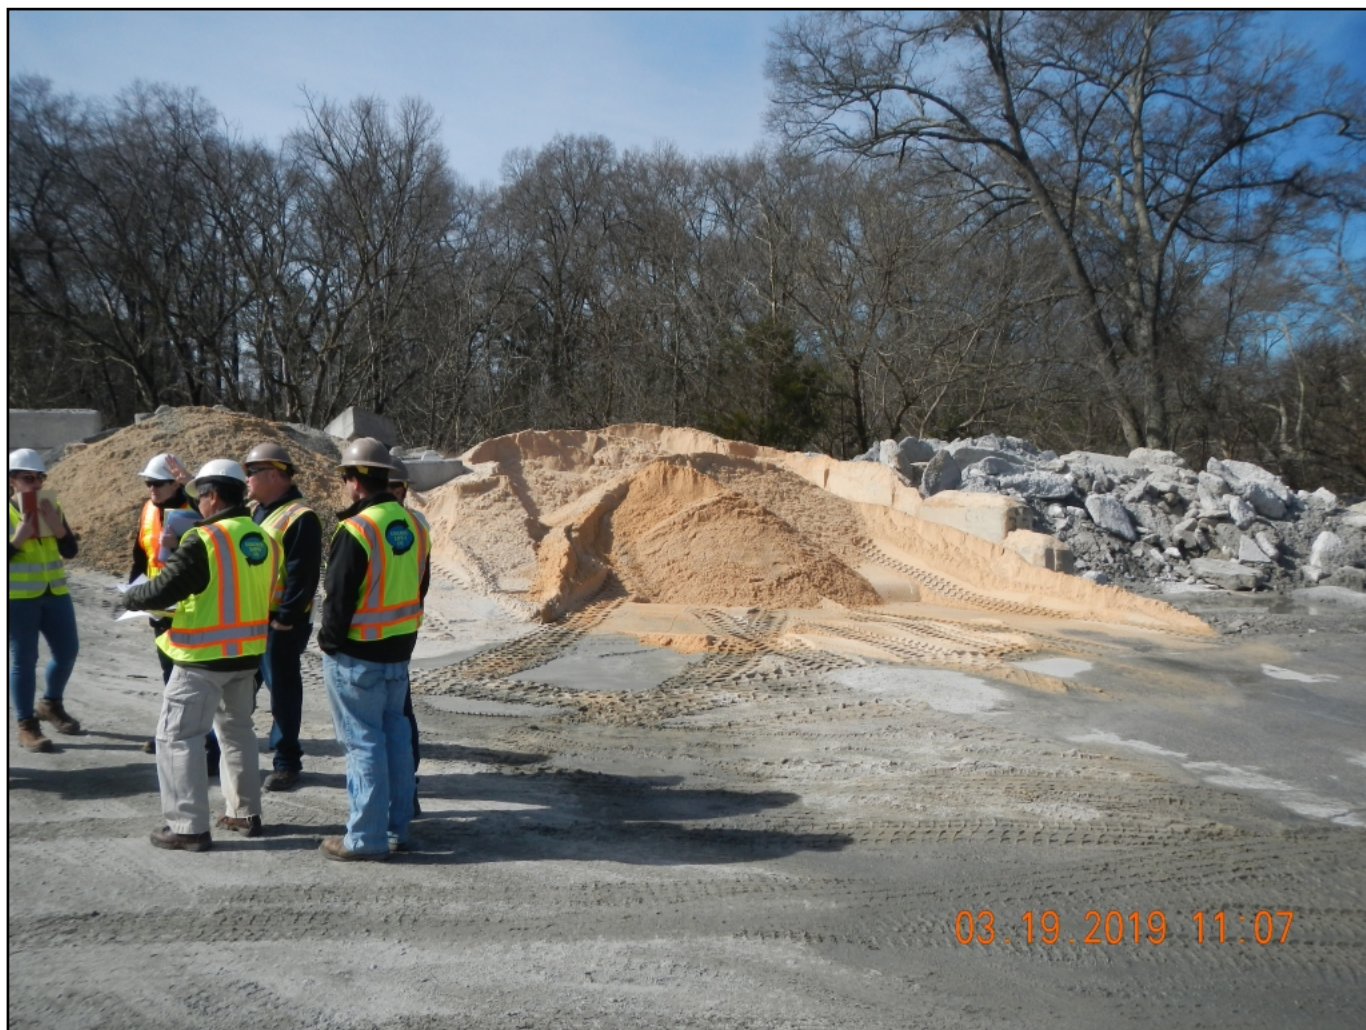
| Attributes | |
|---|---|
| File Name | DSCN1853.JPG |

| Attributes | |
|---|---|
| Description | Photograph of the outdoor material storage piles. |

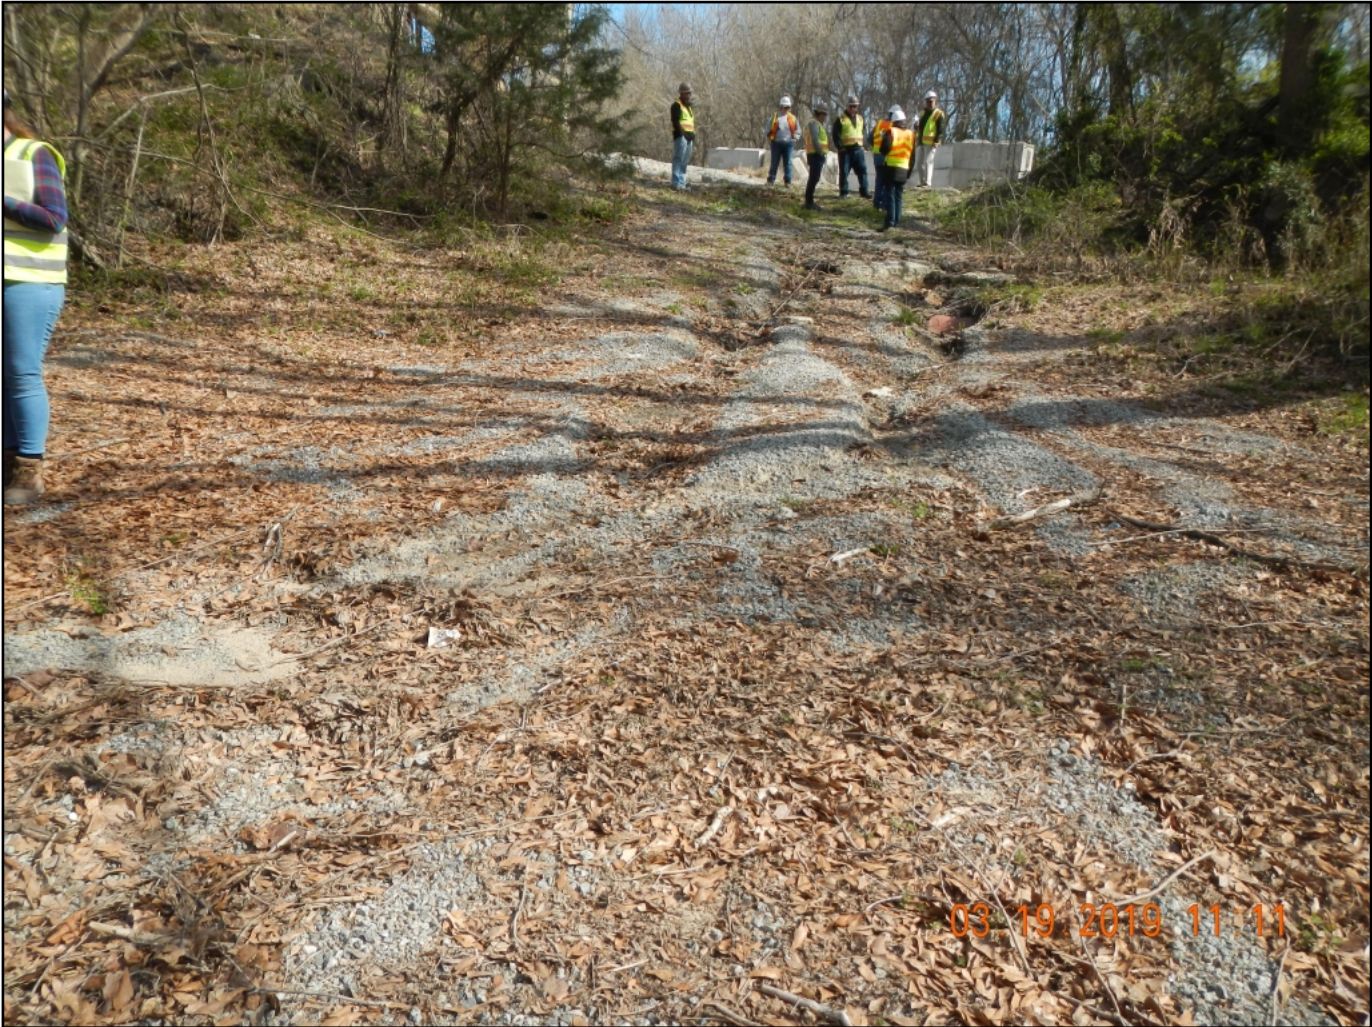
| Attributes | |
|---|--|
| File Name | DSCN1855.JPG |

| Attributes | |
|---|--|
| Description | Junction point with the stream and the old outfall from the site which was considered closed out and removed from its permit requirements. |

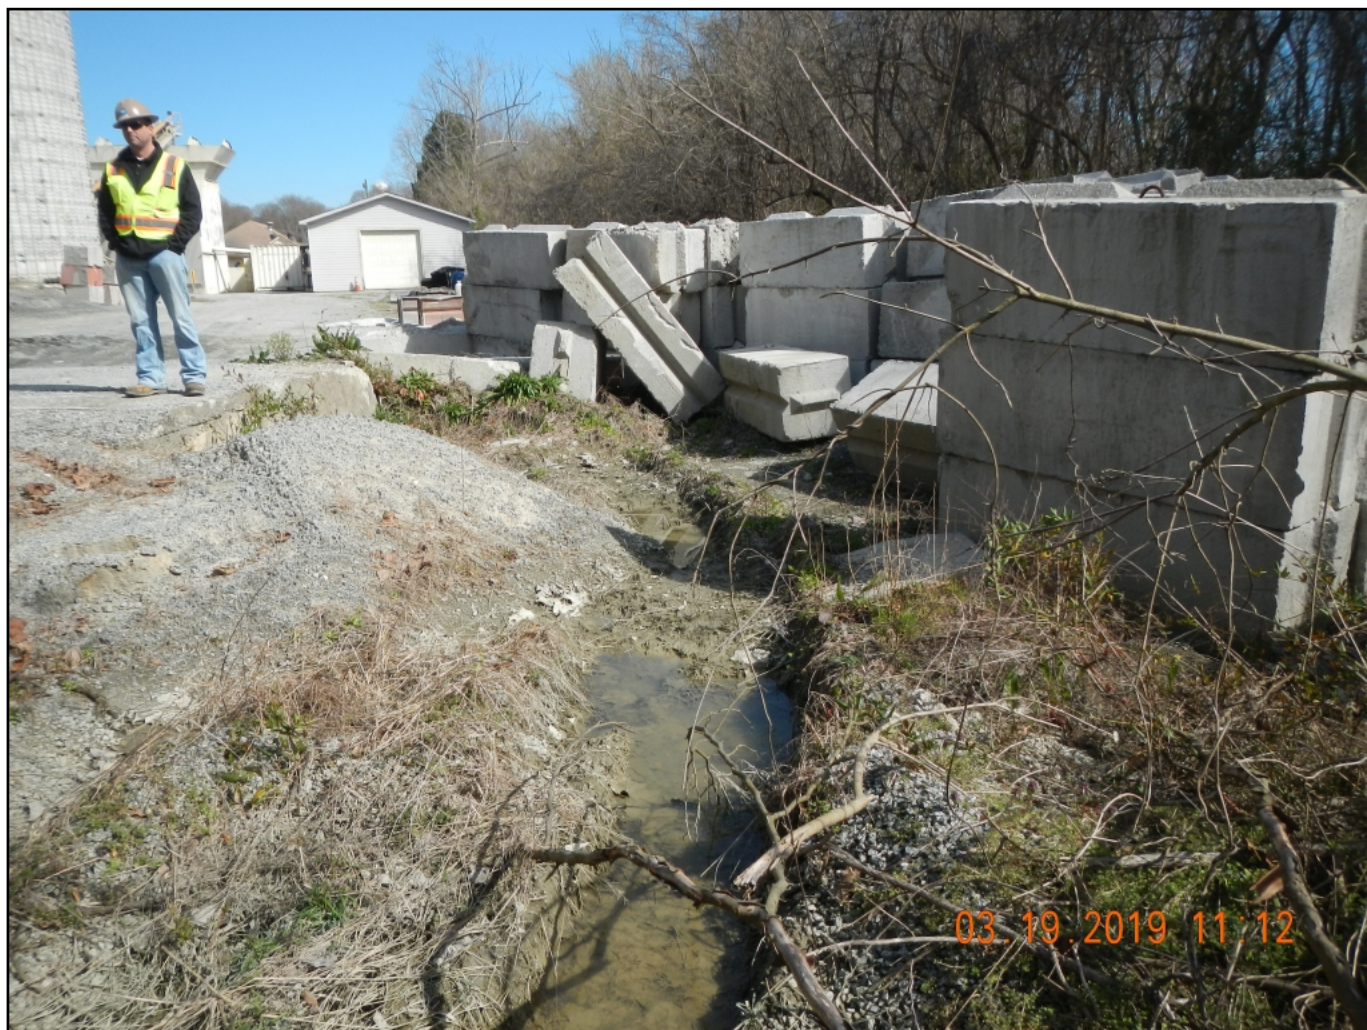
| Attributes | |
|---|--|
| File Name | DSCN1856.JPG |

| Attributes | |
|---|--|
| Description | Down gradient from the former outfall leading to the stream. |
